Investigation on fatigue strength of cut edges produced by various cutting methods for high-strength steels

P. Diekhoff¹ · J. Hensel¹ · Th. Nitschke-Pagel¹ · K. Dilger¹

Received: 9 April 2019 / Accepted: 7 January 2020
© The Author(s) 2020

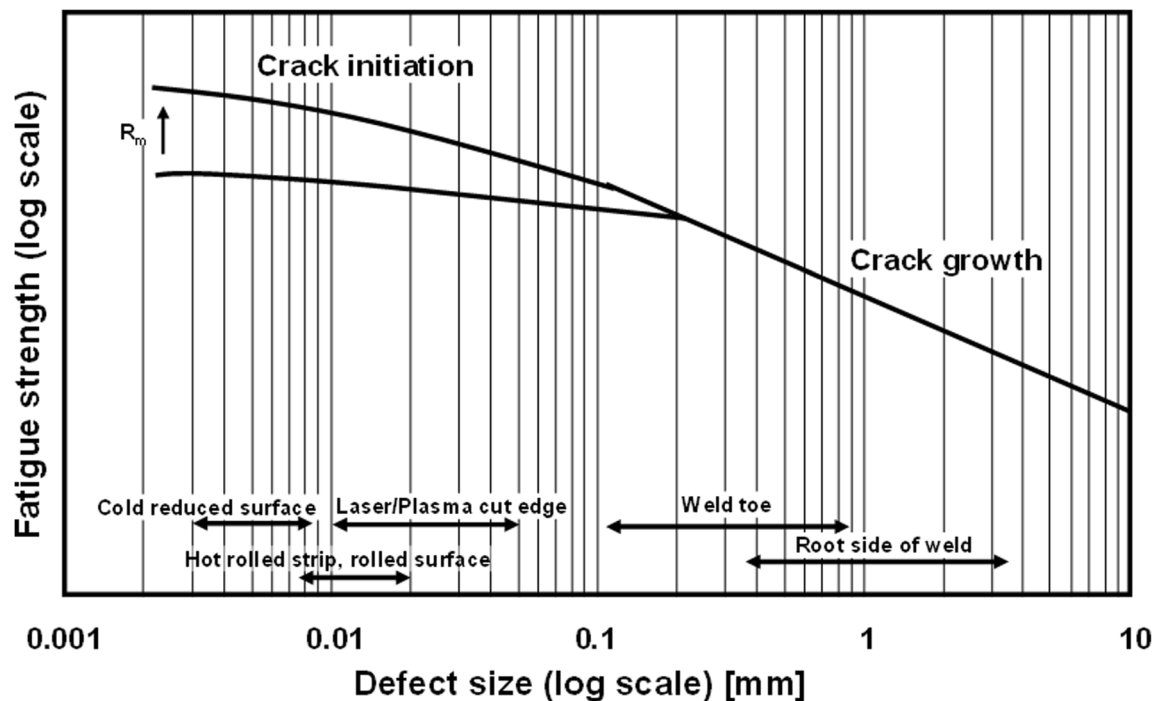
Fig. 1 Schematic Kitagawa diagram showing the influence of the defect size on fatigue strength of different steel strengths (according to Sperle [1])

Cutting technologies used in the industry produce different execution qualities at the cutting edge. The so-called Kitagawa diagram shows the relation between fatigue strength

and defect size based on experimental values [1], as illustrated in Fig. 1. For components with sufficiently large defects, the fatigue strength of the component is characterized by crack propagation phase. With such defect sizes, the fatigue strength does not increase with the tensile strength. The execution quality of cut edges in terms of surface roughness (or “defect size”) directly influences the local stress level and therefore the expected lifetime of the specimens. The lifetime is governed by crack growth in the case of large defects and by crack initiation in the case of small defects. Crack initiation is affected by the hardness respectively tensile strength resulting in an increase of fatigue strength with increasing tensile strength in the presence of small defects. A higher material strength therefore leads to a higher fatigue strength of the component due to the suppressed dislocation movement. In general, for thermal cutting edges, the fatigue strength should increase with tensile strength if the defect is smaller than the corresponding limit value.

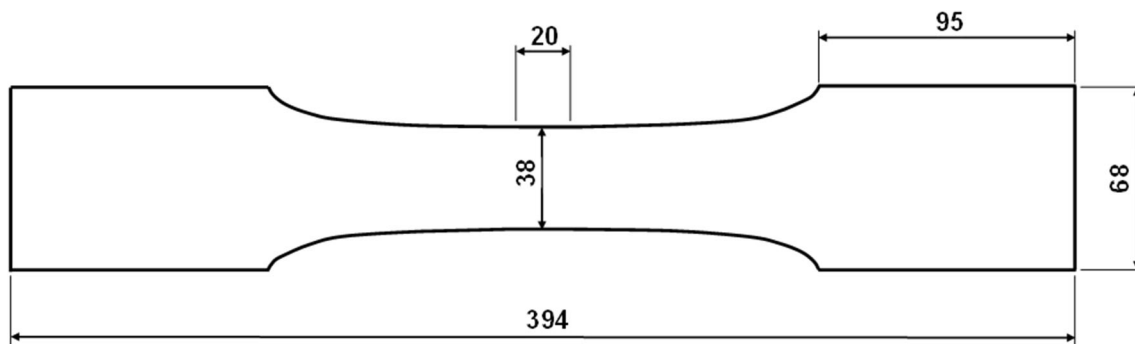
Fig. 2 Dimensions of the dog-bone specimen for fatigue test in millimeters

Fatigue strength of different thermal cut edges of two different steel grades with a minimum yield strength of 355 and 690 MPa was analyzed. The uniaxial test specimen used in this study was similar to previous work in [10] and is shown in Fig. 2. The samples were 394 mm long and 38 mm wide in the critical cross section. Besides the two different steel strengths, the specimens were cut from the 8-mm-thick plate using oxygen, plasma, laser, and waterjet cutting processes. The conditions for the specimens were untreated and defined “as-cut” and quality improvement treatments (posttreatment processes) such as grinding, sandblasting, and cutting speed reduction were used. The laser cutting process changed parameter from a 10-Hz pulsed laser to continuous laser for both steel grades

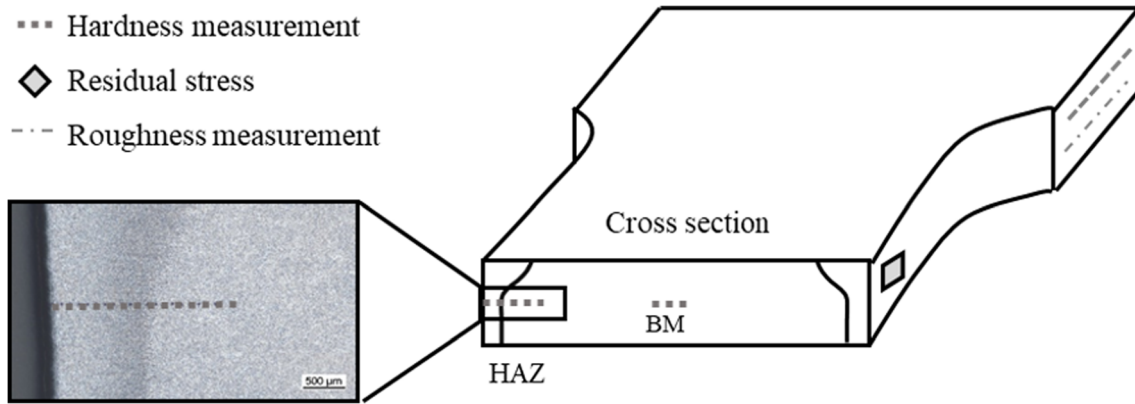
Fig. 3 Location of measurements the quality characteristics

The cut edge conditions were characterized. The location of measurements of the roughness, hardness, and residual stress is shown in Fig. 3. Hardness measurements were made at the cross section and directly at the cut edge (see below).

Surface roughness measurements were made on the specimens according to ISO 4288 [13]. Measurements were done on the cut edge surface (Fig. 3). The tests were carried out with the MarSurf M 400 surface measuring instrument using the profile method over the length of 17.5 mm. From each series, 3 specimens were measured: 3 lines at the top and 3 lines at the bottom of the cut edge surface. The following parameters were determined: The average of the five highest peaks and lowest valleys R_z , the arithmetical average R_a , and the maximum peak to valley height R_{max} . No measurements were done at the plate surface.

The various cutting technologies affect the material close to the cut edge, as shown schematically in Fig. 3. Cutting speeds related with the cooling rates have an influence on the size of the heat-affected zone (HAZ). The CEV of the steel grades determine the possible maximum hardness. Figure 6 shows hardness measurements on the cross section for S355M, 8 mm and S690Q, 8 mm. The curves are plotted just for thermal cutting technology oxygen, plasma, and laser condition as-cut. All measurements were done approx. 2 mm from both edges into the unaffected base material. Concerning the hardness measurements, the HAZ is less than 500 μm wide. Higher strength steels coming up with higher CEV implicate higher hardness values at the thermally cut edges. Comparing the cutting processes, plasma cutting achieves the highest hardness value. No hardness increase is observed at the oxygen cut S355M. The rapid change in the hardness profile of 8-mm-thick plates indicates a very small heat-affected zone. Laser cut specimens have a small HAZ with only one hardness measurement point. Regardless of the steel grade, the maximum hardness value is between 200 HV0.1 and 510 HV0.1. It implicates a relatively increased hardening compared with the base material from 10 to 170%. The results shown are comparable to previous work [2, 4, 10].

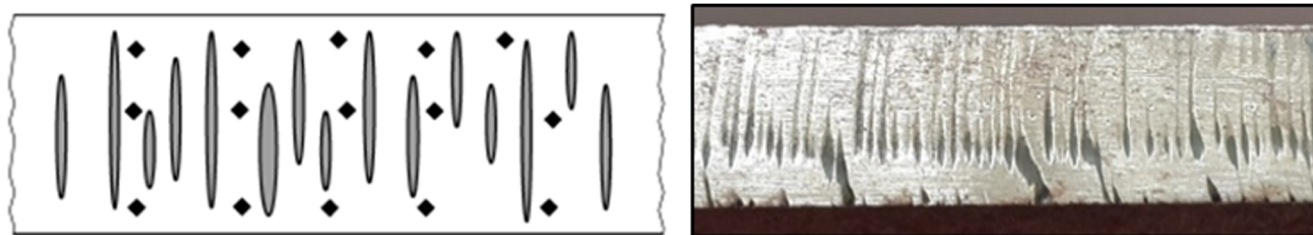
Fig. 4 Left: Location of measurements at the ground cut edge (schematically). Right: Ground cut edge

were made for waterjet cut plates, because no changes to the base material were expected. Additionally the hardness was measured directly at the cut edge according to the instruction from the Appendix in the DIN EN 1090-2:2017 draft. UCI (ultrasonic contact impedance) method was used [15]. Cut edges have to be prepared and ground using a P600 abrasive paper. Valleys of the surface should be visible. Measurements are made as seen in Fig. 4.

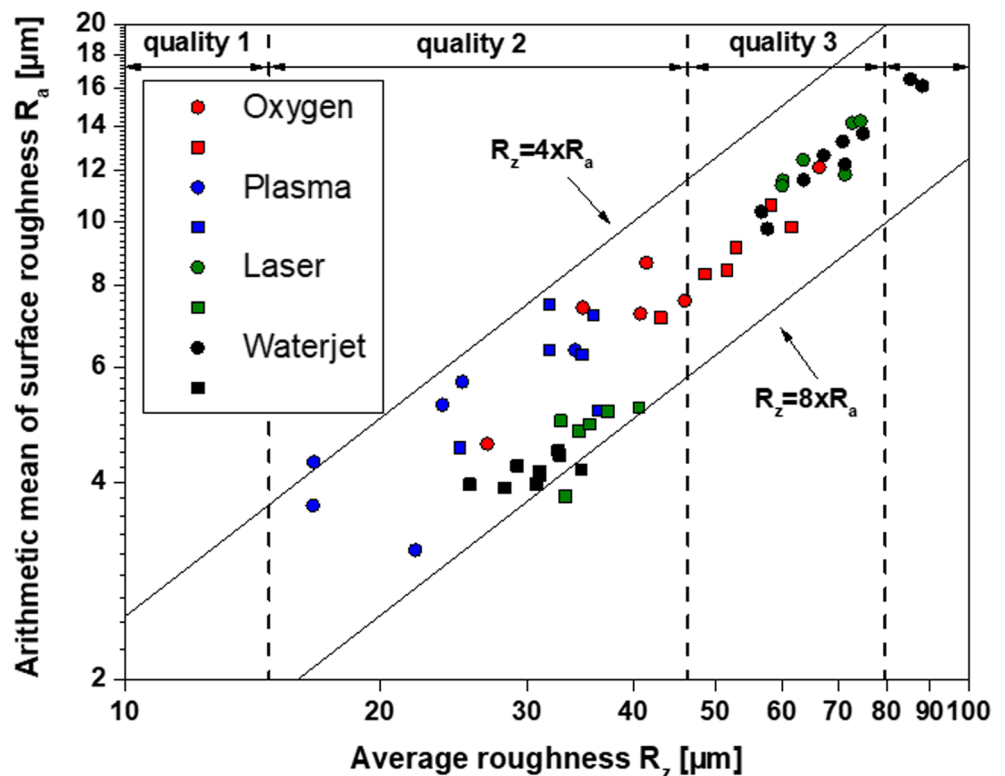
Fig. 5 Arithmetic mean of surface roughness R_a as a function of arithmetical peak-to-peak average roughness R_z for different cutting technologies (S355M, 8 mm)

The measured roughness parameters on the cut edge are the average of the five highest peaks and lowest valleys R_z , the arithmetical average R_a , and the maximum peak to valley height R_{max} . The results are summarized in Table 5. The corresponding roughness measurements and allowable ranges, according to ISO 9013, are shown in Fig. 5. It demonstrates the arithmetic mean of surface roughness R_a as a function of arithmetical peak-to-peak average roughness R_z for different cutting technologies and steel strengths (thickness 8 mm). The different quality groups according to the ISO 9013 for 8-mm-thick plates are also shown on the top of the figure. The cutting technologies have various colors (red—oxygen, blue—plasma, green—laser, black—waterjet)

and the cut edge condition is marked as a cycle (as-cut) or as a square (improved quality).

All measurements can be classified in range 2 and range 3. Plasma cut edge specimens show the best quality of all cutting technologies, which defined in quality range 2. Oxygen cut edge has a high scatter between ranges 2 and 3. For the laser and waterjet cut edges, the figure shows some differences. Depending on the cutting speed, two different qualities can be reached. For high cutting speed, the roughness is also high and the quality range is 3. A reduction of the cutting speed increases the quality and the roughness is low (R_z 27–41, quality range 2).

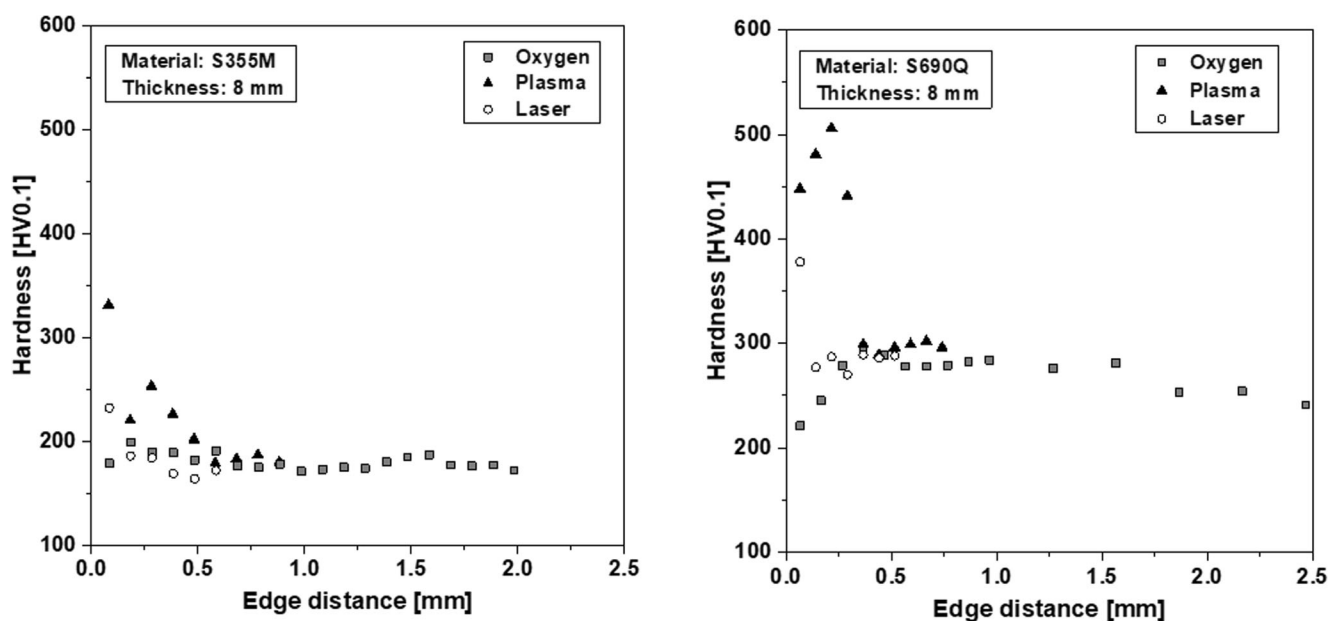
Fig. 6 Hardness measurements on the cross section of S355M 8 mm (left) and S690Q 8 mm (right)—oxygen, plasma, and laser cut specimens

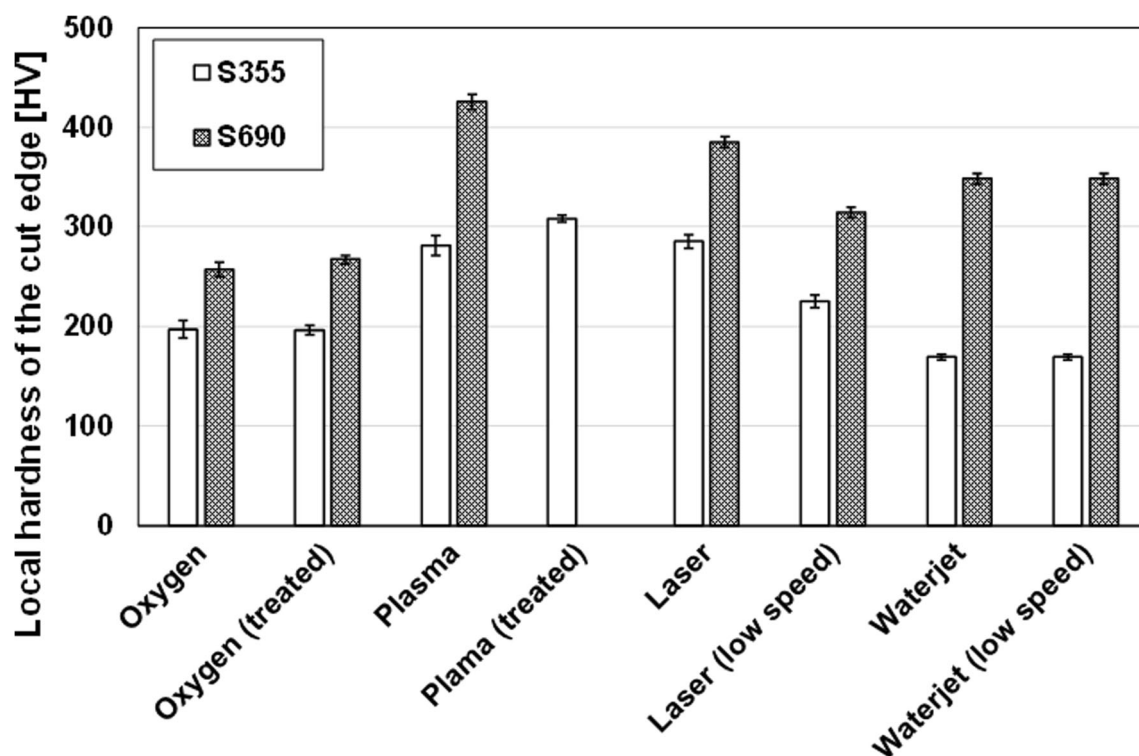
Fig. 7 Local hardness on the cut edge of all series tested

Additionally the local hardness of the cut edges of all series tested is shown in Fig. 7. The hardness was measured directly at the cut edge. Due to the higher test load (HV10), the local hardness at the cut edge is smaller than the maximum on the cross section. Because of the thin hardened layer, the preparation of the cut edge may remove the HAZ a little bit. Shot peening and grinding do not change the hardness value. The cutting speed reduction increases the cooling rate and the local hardness at the cut edge decreases (laser cut edges).

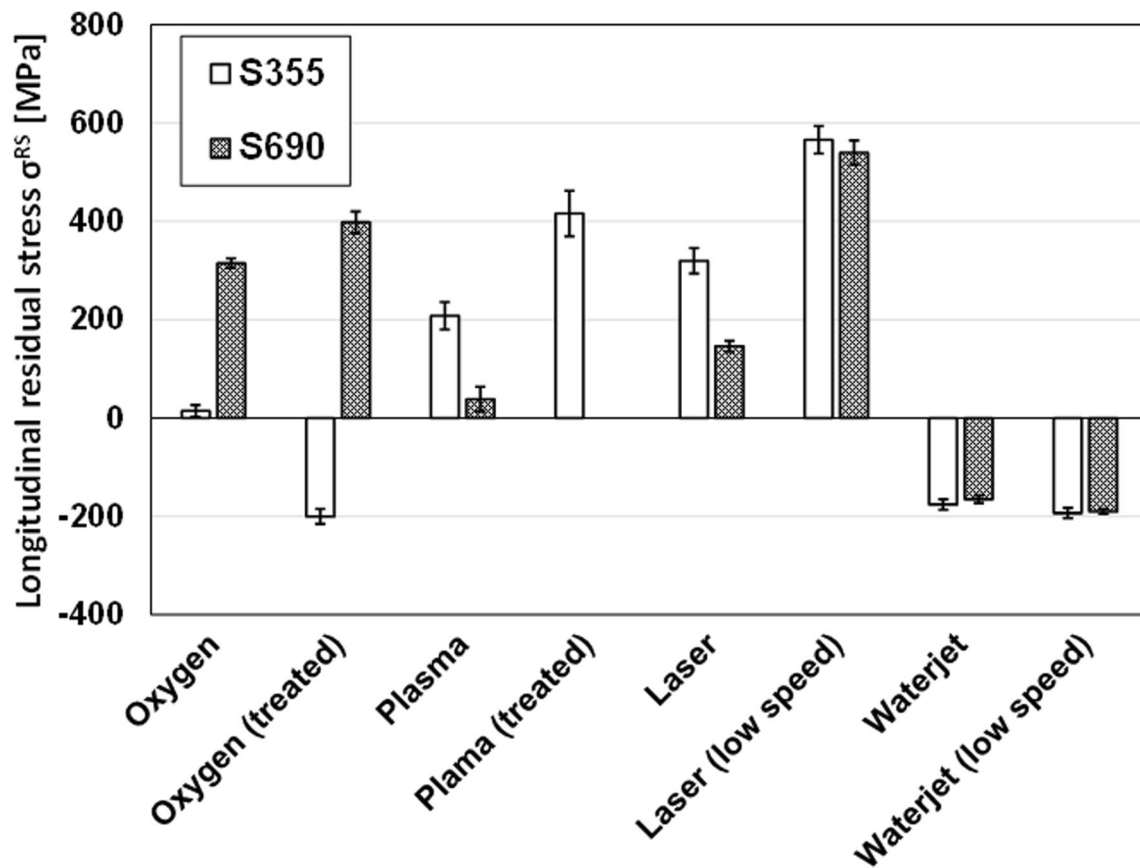
Fig. 8 Residual stress on the cut edge of all specimens tested

The residual stresses on the cut edge for the different cutting technologies and materials used are given in Fig. 8. It was measured parallel to the loading direction. Measurement results are very different. Waterjet cut edges show compressive residual stresses over the cut edge about -200 MPa. The shot peened surface shows compressive residual stresses also, approx. -200 MPa. Oxygen cut high-strength steels, all plasma and laser cut edges show tensile residual stress. Compressive stress on oxygen cut edges and on waterjet cut edges was also seen in [3]. They measured tensile residual stress just on plasma and not on laser cut edges. Remes et al. as well as Lillemäe

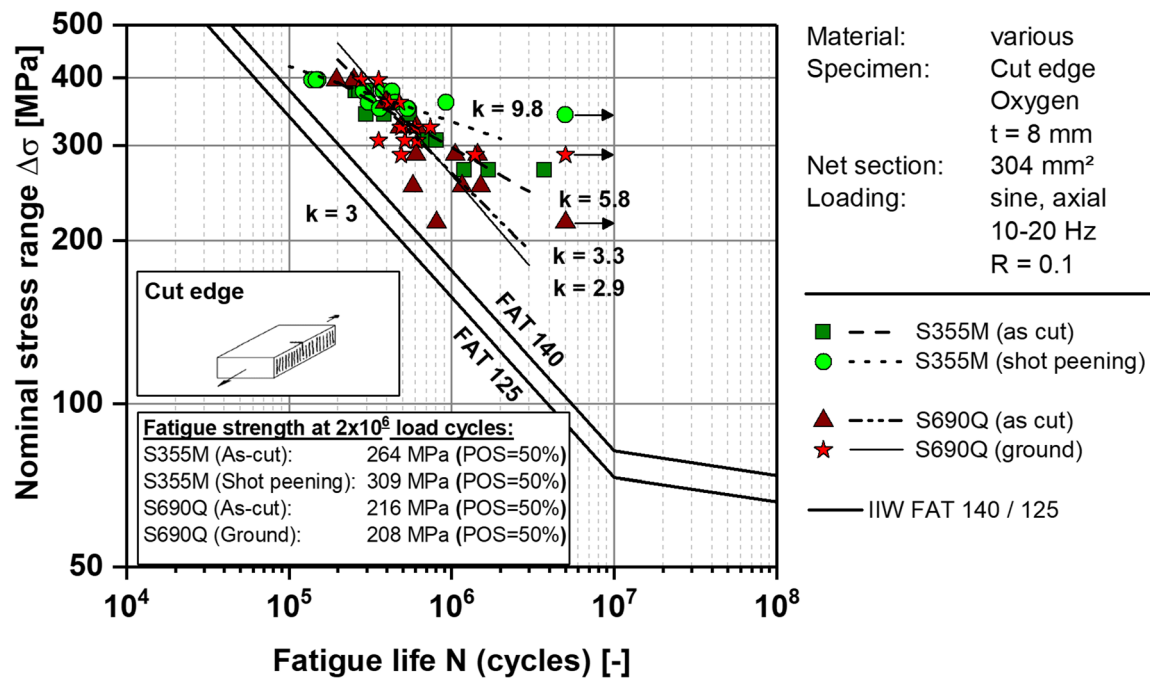
Fig. 9 Fatigue test results of oxygen cut edges, 8-mm-thick specimen, stress ratio $R = 0.1$. Shown here are test series 1 and 2 and 9 and 10

Figure 9 shows the test data from oxygen cut specimens made from S355M and S690Q. The fatigue strength is sum up at the bottom left in the figure. The results show different fatigue strength and slopes. Specimens cut by oxygen cutting

of S355M without using any posttreatment method show a nominal fatigue strength range at 2 million load cycles of $\Delta\sigma = 264$ MPa (POS = 50%). The regression line was calculated to $k = 5.8$ without run outs including. The benefit of shot peening series is primary at higher numbers of load cycles. The fatigue strength increase was determined to $\Delta\sigma = 309$ MPa at 2 million load cycles with a flat slope of $k = 9.8$, 117% increase of fatigue strength to the as-cut series. Short-

term strength of both series is comparable. No increase was observed using S690Q compared with S355M. Fatigue strength decreased to $\Delta\sigma = 216$ MPa. Contrary to the expectations, S690Q (ground) specimens show similar extrapolated fatigue strength results about $\Delta\sigma = 208$ MPa. Due to high number of load cycles at $\Delta\sigma \approx 400$ MPa, the slope of k gets very steep and the calculated fatigue limit down to 208 MPa. Even though run outs have a significant higher $\Delta\sigma$ of 288 MPa compared with S690 (as-cut) specimens at $\Delta\sigma = 216$ MPa. The small amount of specimens especially for a high stress range could be one reason for it.

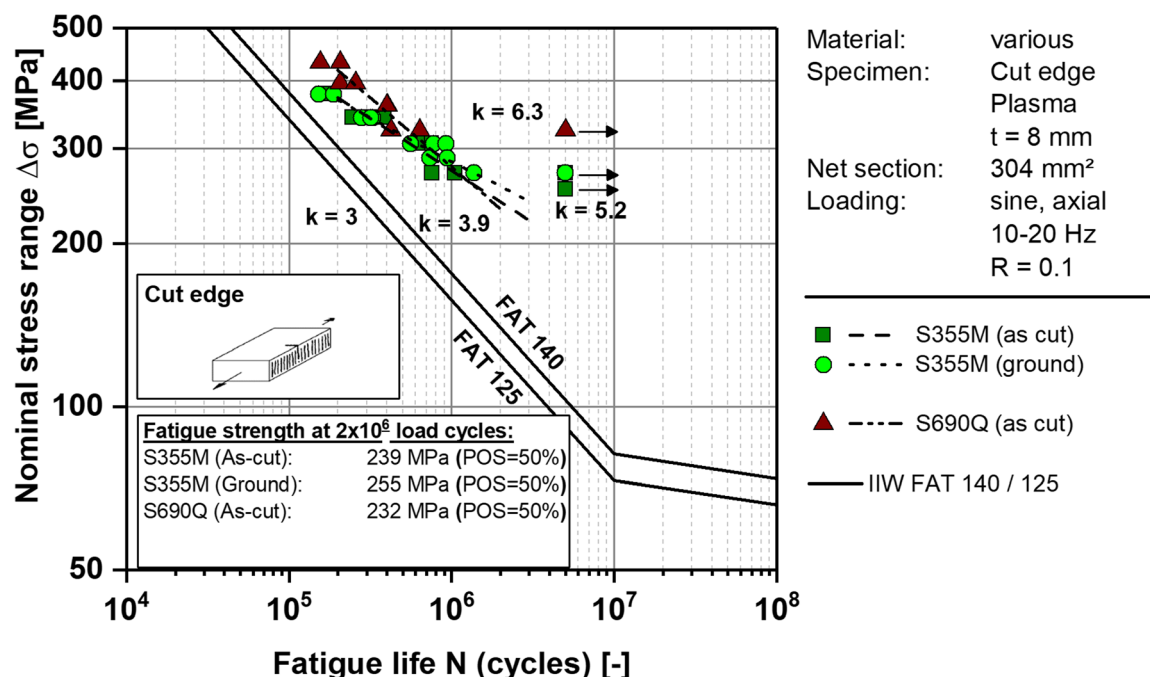
Fig. 10 Fatigue test results of plasma cut edges, 8-mm-thick specimen, stress ratio $R = 0.1$. Shown here are test series 3, 4, and 11

Test data from plasma cut specimens is shown in Fig. 10. Results of S355M specimens (as-cut) show fatigue strength at $\Delta\sigma = 239$ MPa with a slope of $k = 5.2$. A slight improvement of grinding the cut edge surface was observed. The fatigue strength was calculated to $\Delta\sigma = 255$ MPa at 2 million load cycles with $k = 5.2$. The benefit of using high-strength steels is most prominent at higher number of load cycles. Run outs have a significant higher stress range. But the fatigue strength was also calculated to a comparable level because of the steep slope $k = 3.9$ ($\Delta\sigma = 232$ MPa).

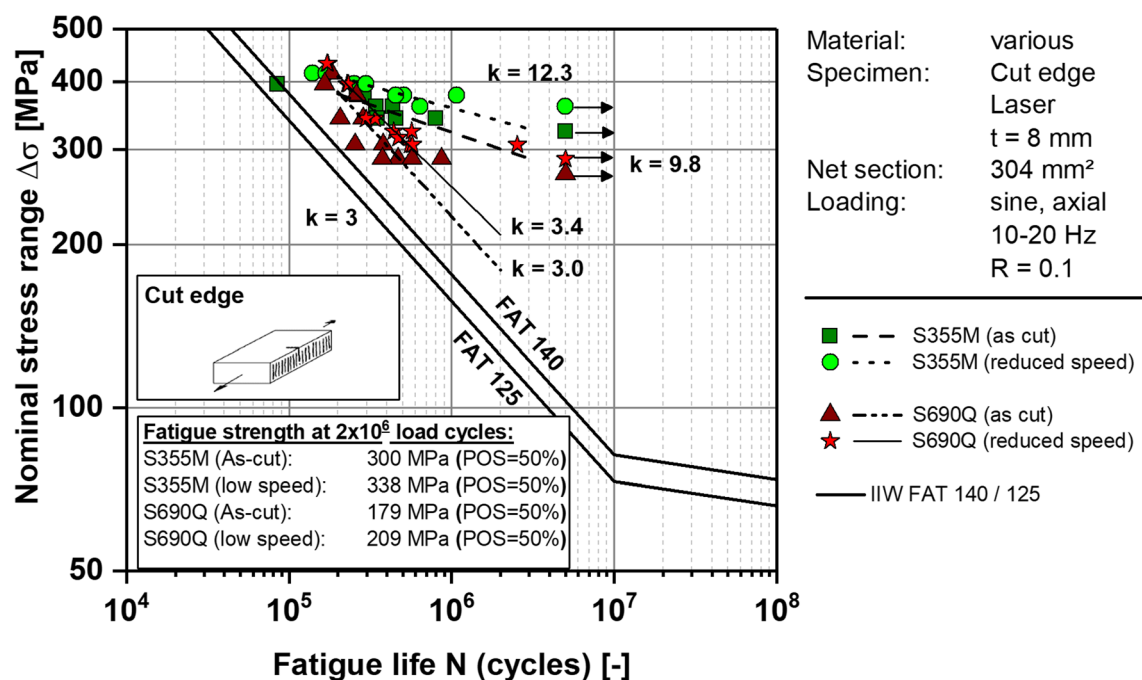
Fig. 11 Fatigue test results of laser cut edges, 8-mm-thick specimen, stress ratio $R = 0.1$. Shown here are test series 5 and 6 and 12 and 13

Fatigue test results of laser cut edges of 8-mm-thick specimens are illustrated in Fig. 11. For both materials, an increase of fatigue strength at 2 million load cycles was determined when the cutting speed is reduced. S355M $\Delta\sigma = 300$ MPa

(as-cut) $\rightarrow \Delta\sigma = 338$ MPa (reduced speed) and S690Q $\Delta\sigma = 179$ MPa $\rightarrow \Delta\sigma = 209$ MPa. The slopes of S355M S-N curves are significantly higher (k between 9.8 and 12.3) than the slopes of S690Q S-N curves (k between 3.0 and 3.4). It is also observed that the fatigue strength decreases for the high-strength steel. The cutting speed reduction leads to an improvement of the fatigue limits. One reason could be the geometrical improvement of the surface, despite the tensile residual stress on the cut edges.

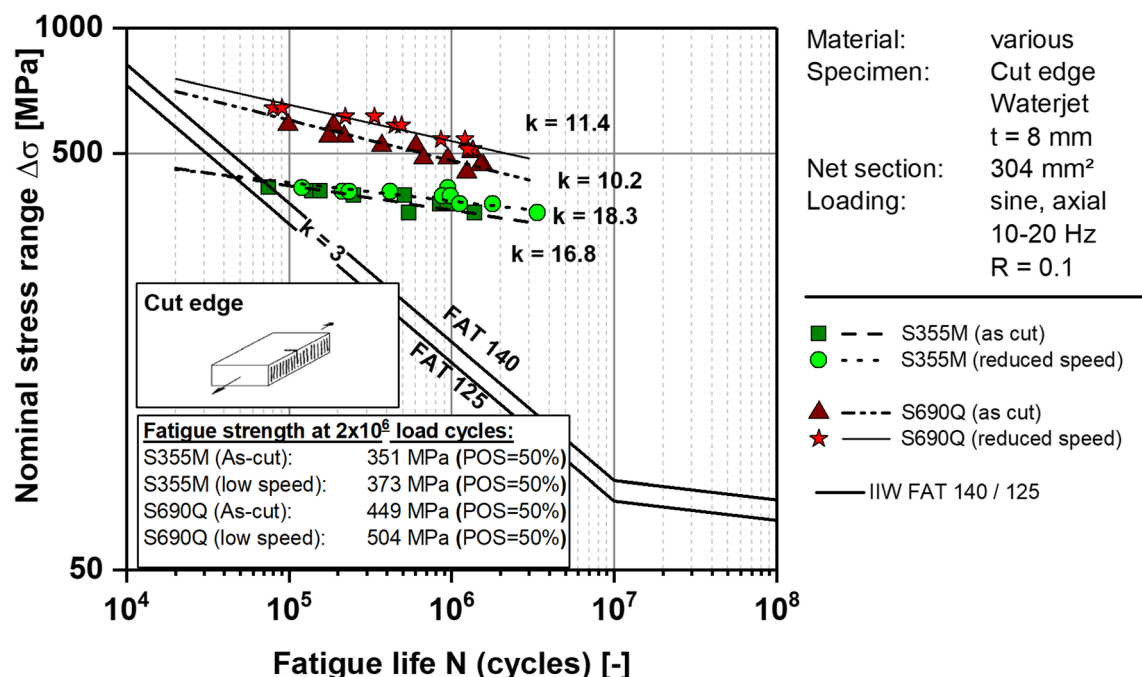
Fig. 12 Fatigue test results of waterjet cut edges, 8-mm-thick specimen, stress ratio $R = 0.1$. Shown here are test series 7 and 8 and 14 and 15

The highest fatigue strength results were calculated for waterjet cut specimens. Figure 12 shows the test data from specimens made from S355M and S690Q with normal (as-cut) and reduced cutting speed. The regression lines of all four S-N curves are very flat and the slopes are comparable ($k = 10.2$ – 18.3). As well as the laser cut edges, waterjet cut edges show an increase of fatigue strength at 2 million load cycles using a reduced cutting speed. S355M $\Delta\sigma = 351$ MPa (as-cut) $\rightarrow \Delta\sigma = 373$ MPa (reduced speed) and S690Q $\Delta\sigma = 449$ MPa $\rightarrow \Delta\sigma = 504$ MPa. The effect of an increased fatigue strength using high-strength steels is seen.

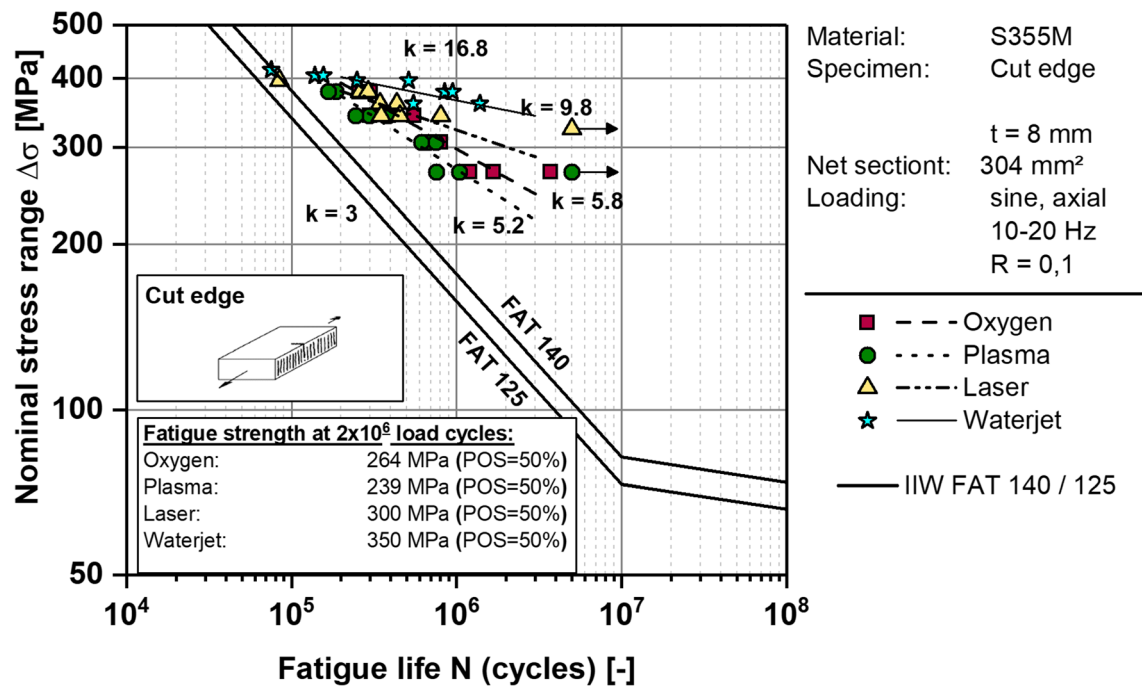
Fig. 13 Comparison of all various cutting technologies of S355M, 8 mm (as-cut)

A comparison of all various cutting technologies of S355M specimens with a thickness of 8 mm is shown in Fig. 13. The plasma cut S-N curve shows the lowest fatigue strength $\Delta\sigma = 239$ MPa with $k = 5.2$. Oxygen cut edges have a slightly higher fatigue strength level at $\Delta\sigma = 264$ MPa with $k = 5.8$.

Laser cut edges have a fatigue strength at $\Delta\sigma = 300$ with $k = 9.8$ and the highest fatigue strength results were determined for waterjet cut edges at $\Delta\sigma = 351$ MPa with a flat slope of $k = 16.8$.

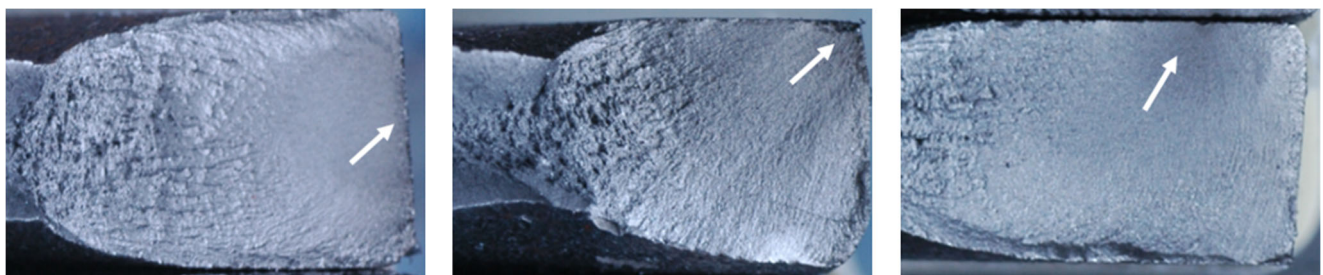
Fig. 14 Location of crack initiation (cut edge, corner, and plate surface)

The fracture surface analysis points out three different locations of crack initiation: on the cut edge, at the corner between cut edge and rolled plate surface, and at the plate surface. Figure 14 presents an example of each location of the crack initiation. In Table 6, the percentage distribution of all the test specimens is summarized. The crack initiated mostly from the corner or even from the rolled plate surface (cf. [4]).
